HISTORIC RESOURCE STUDY

BANNACK STATE PARK

est.
Historical Research Associates
Missoula, Montana

July 1982

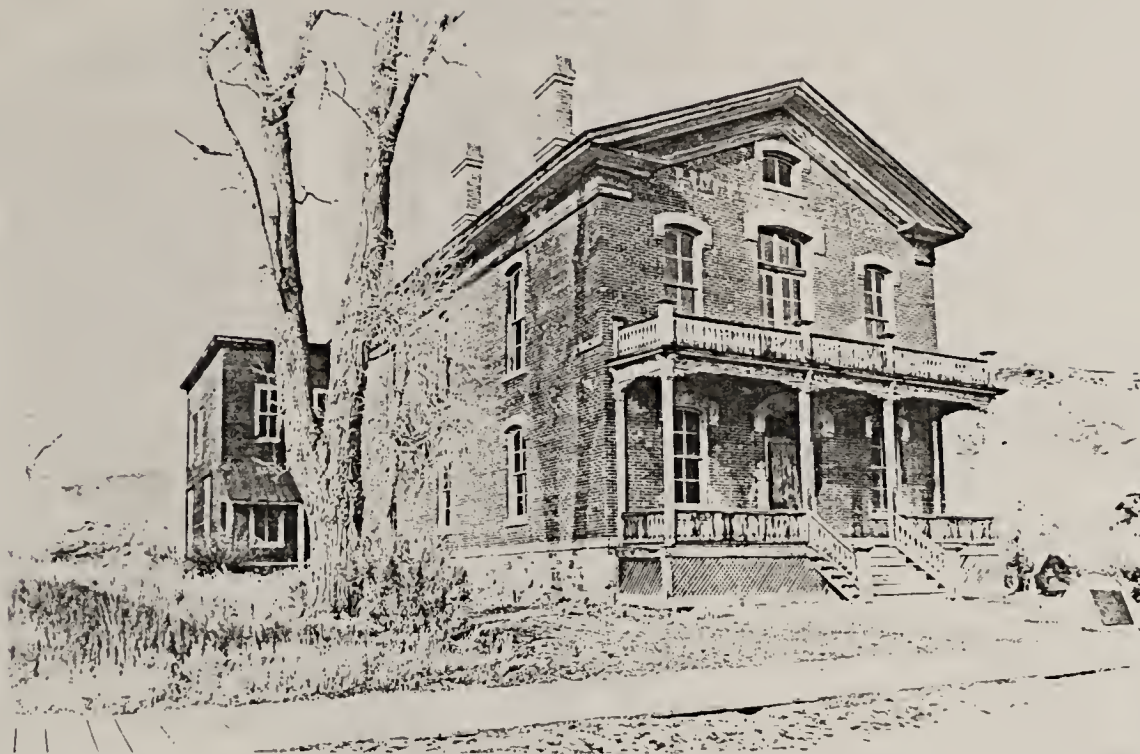
Figure 3-12. Looking northeast at the Meade Hotel.

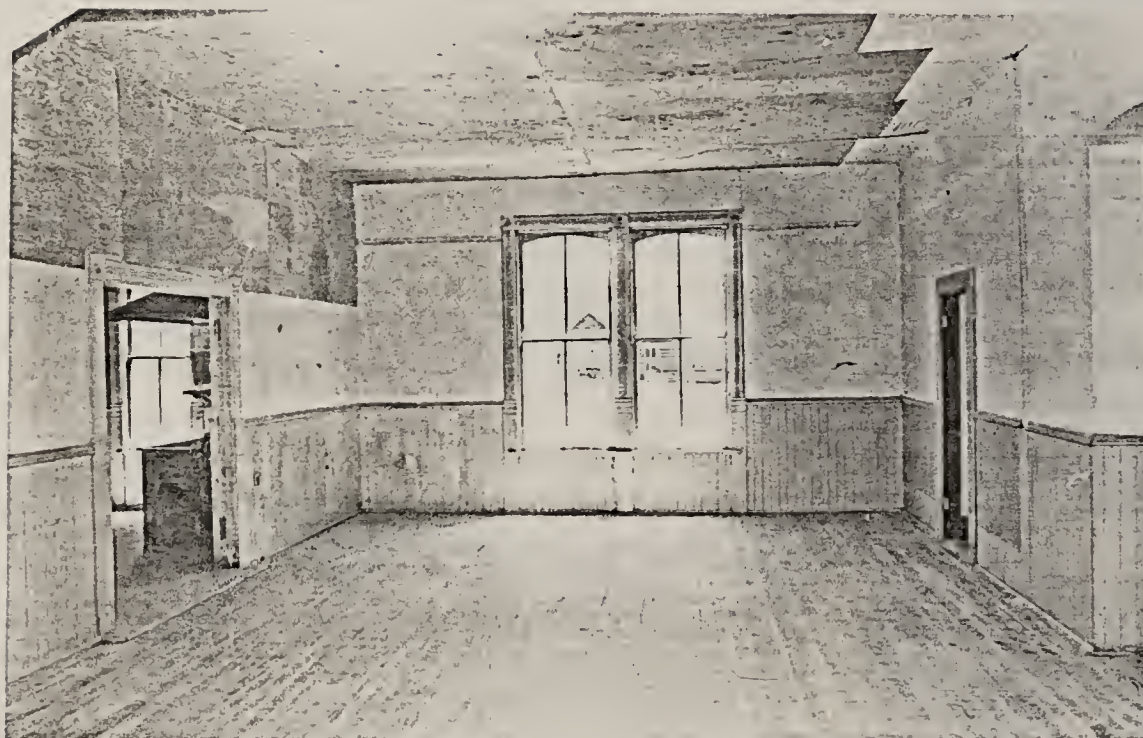
[Plywood ceiling]

[Plaster]

[Wood floors]

Figure 3-17. Looking at the dining room.

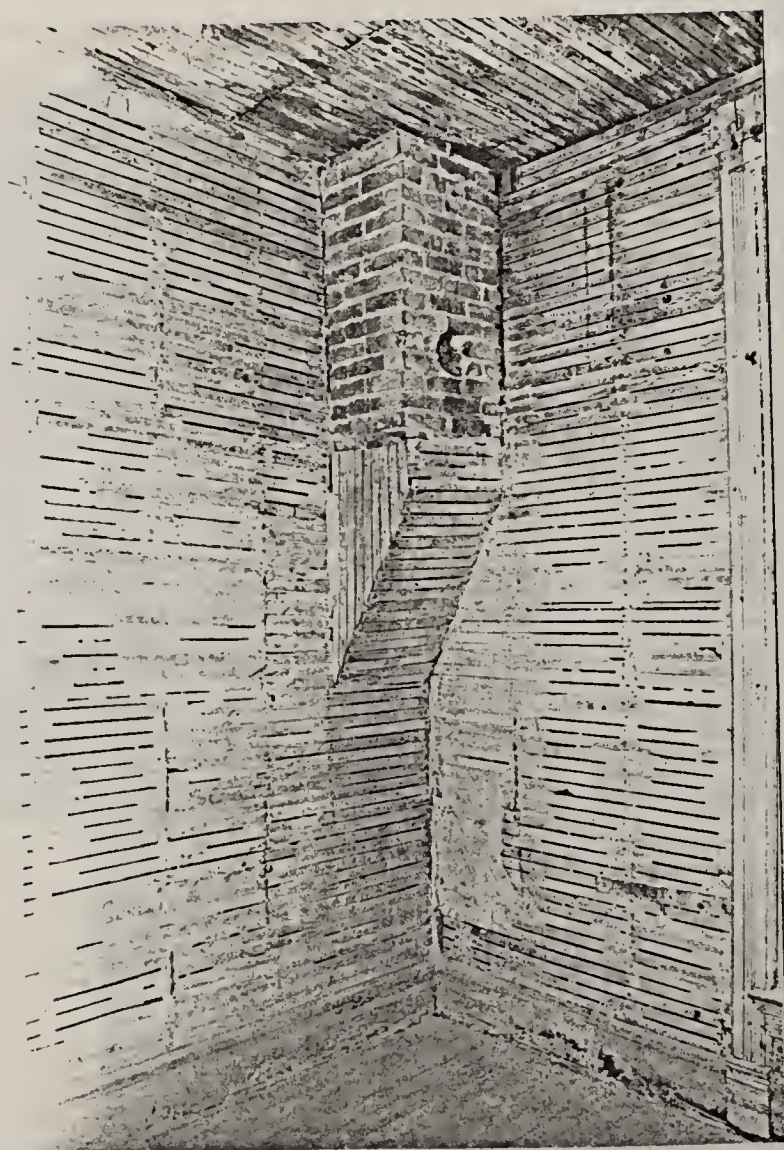
Figure 3-21. Looking at a typical chimney.

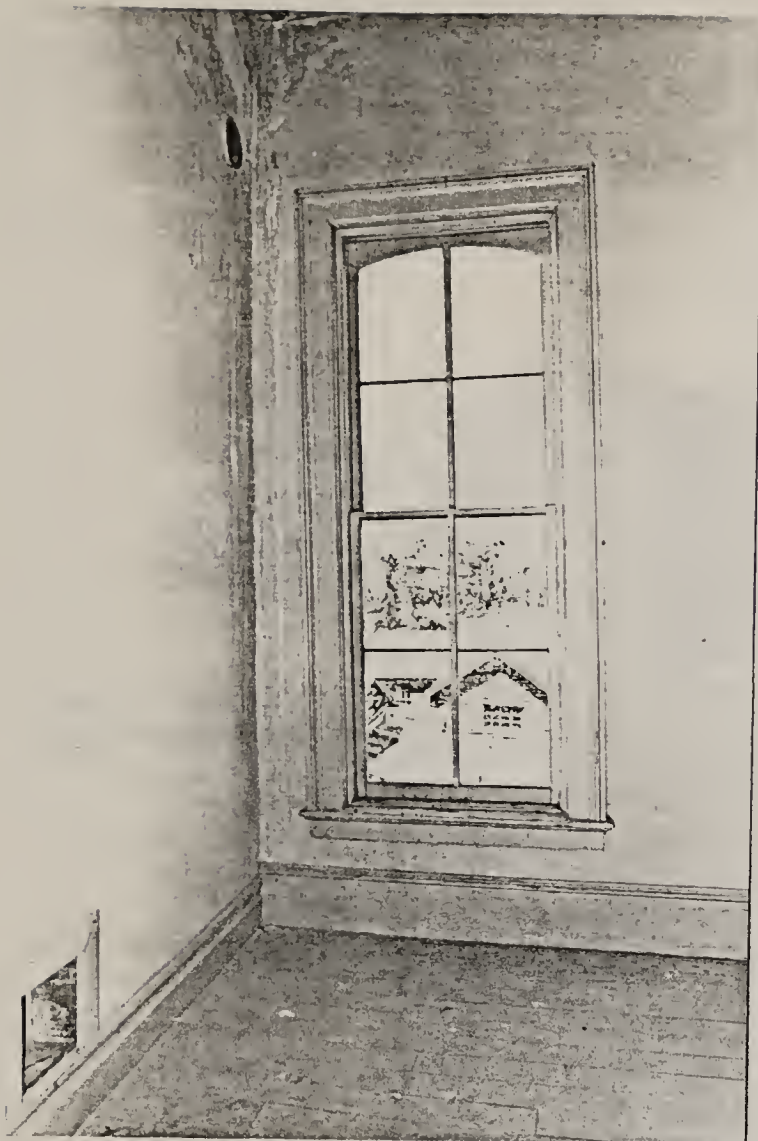
Figure 3-22. Looking out a typical window.

[Interior frames and sash are good]

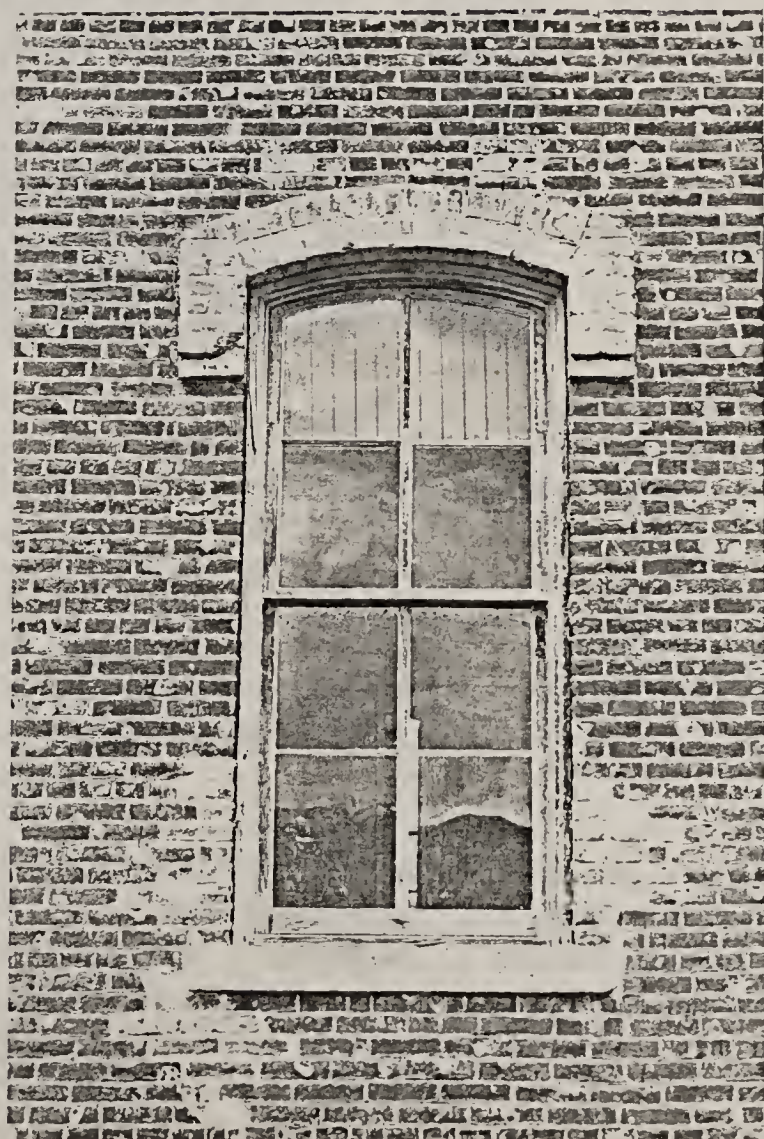
[Weathered
window trim
and sash]

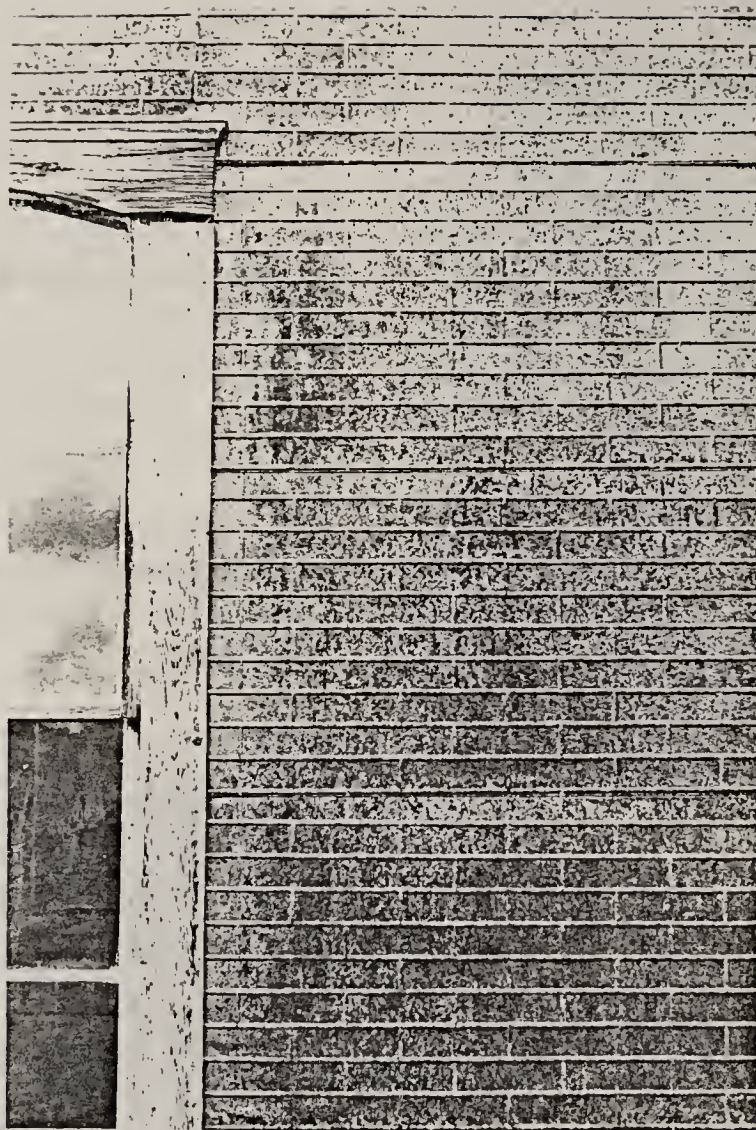
[Pressed metal
brick pattern
siding]

Figure 3-24. Looking at the pressed metal brick pattern siding of the frame section of the Meade Hotel.

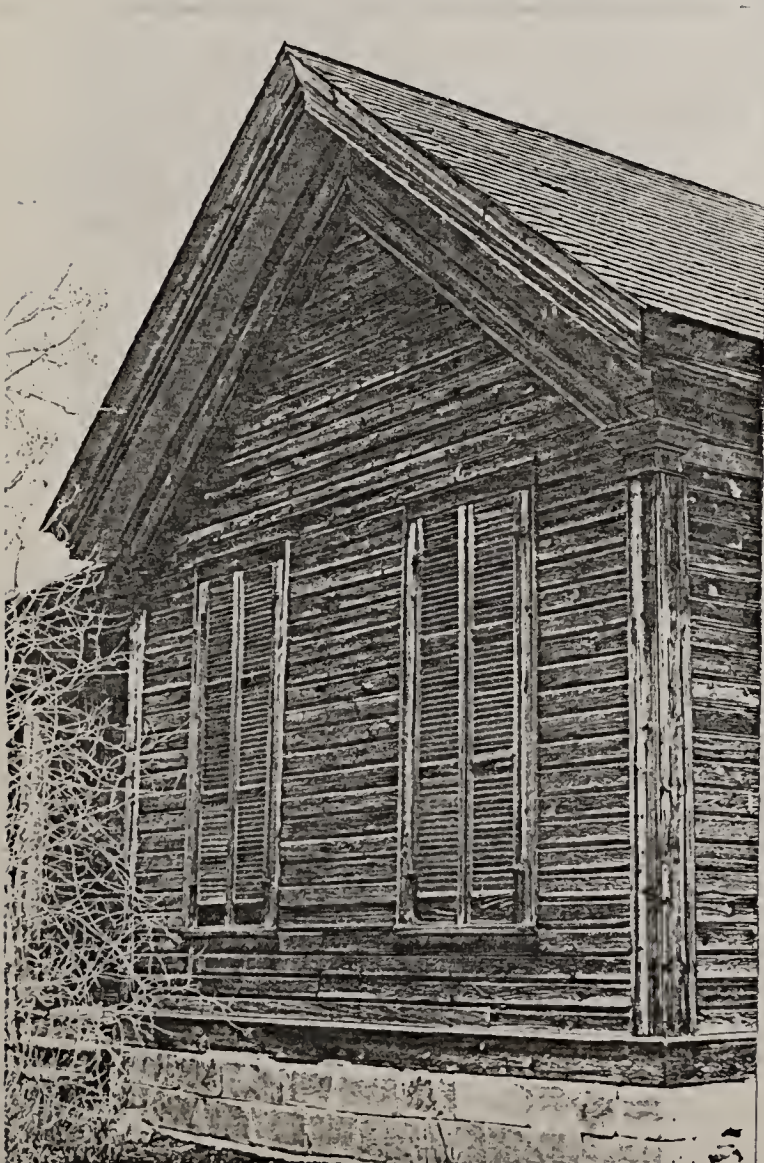
[Heavy raking cornice]

[Doric corner pilaster]

Figure 3-27. South facade.

[Stone foundation]

This structure was donated to the Department in 1973 by the Merle Erwin estate. The following work has been accomplished on the main residence: 1975-77--repaired the stone foundation and poured a concrete foundation under it at ground level, stabilized the walls in the northwest corner, replaced deteriorated roof sheathing where necessary, re-roofed with cedar shingles, replaced metal porch roof, repaired downspouts from porch; 1978--rebuilt chimneys.

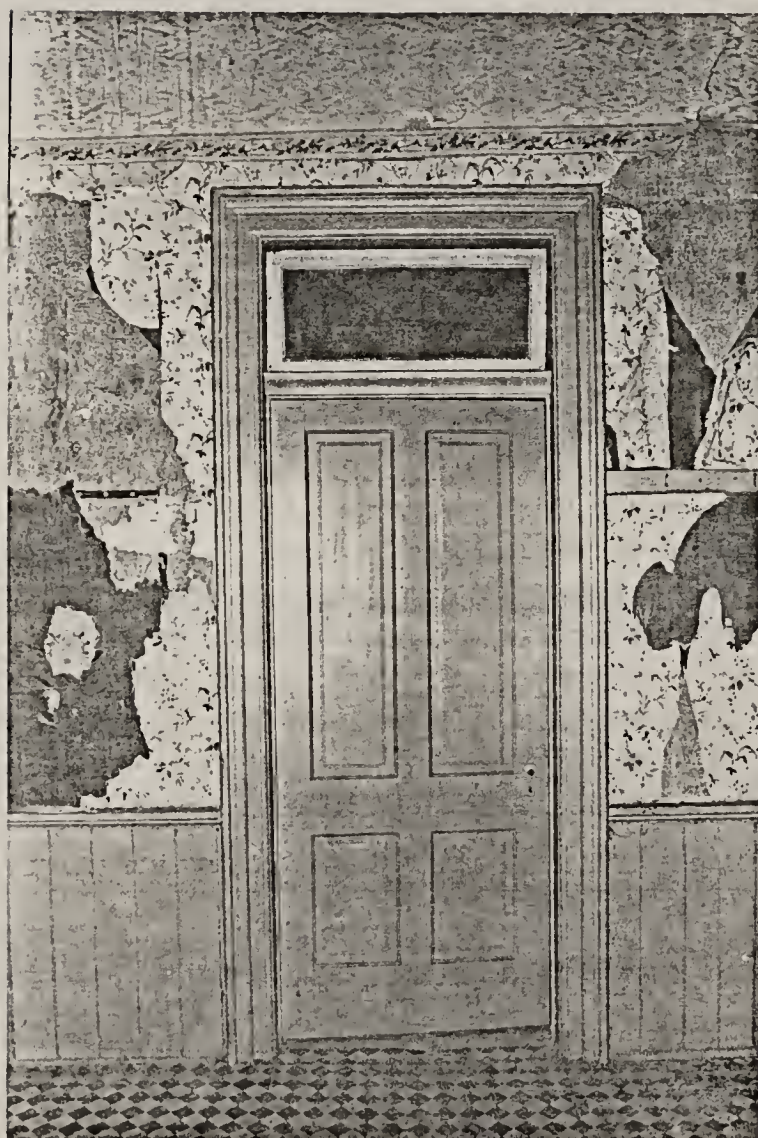
[Layers of wall covering
revealing possible original
wallpaper]

[Wood panel door with transom
and milled architrave]

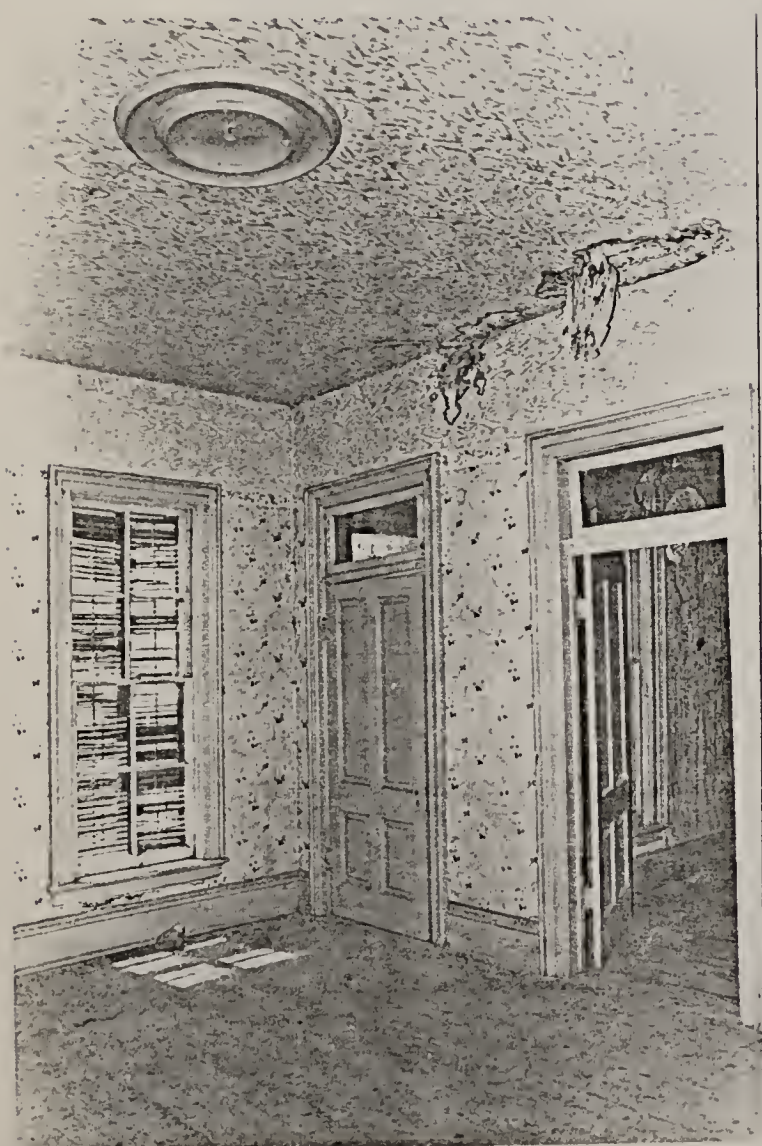
Figure 3-31. Interior showing
condition.

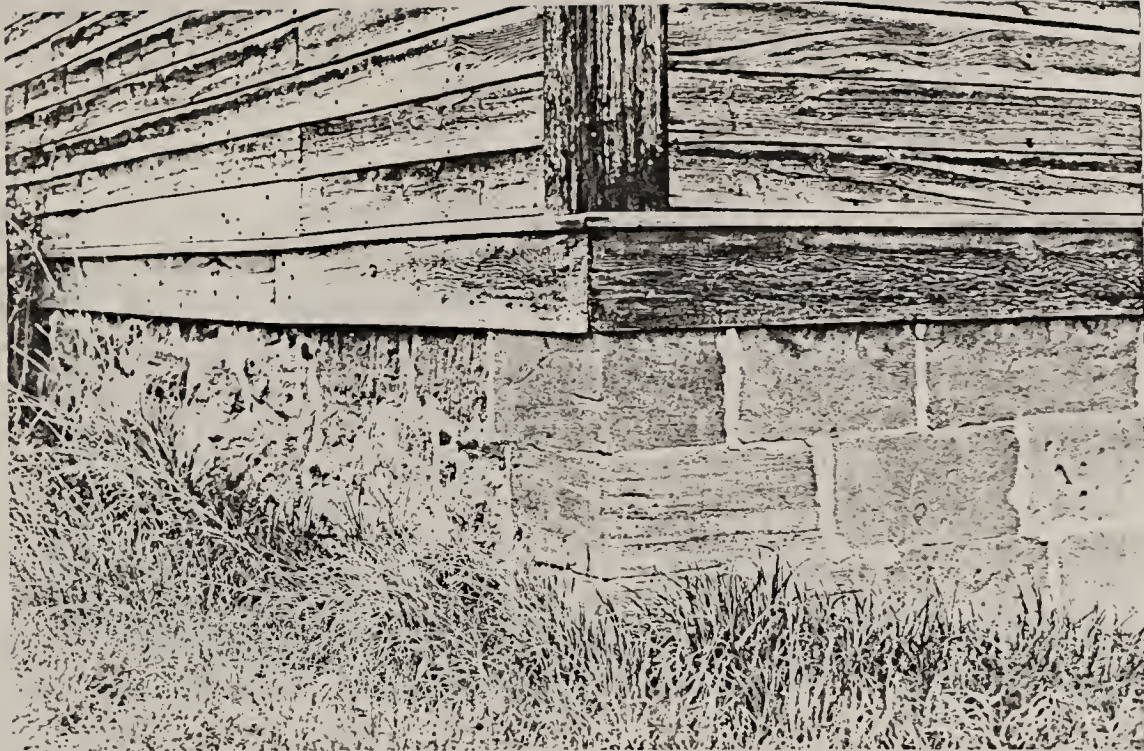
The sill at the top of the base is an apron-board and drip-cap. Clapboard siding terminates with vertical corner boards. Gable ends are sided in a continuation of the clapboard.

Figure 3-36. Outside corner at base and sill.

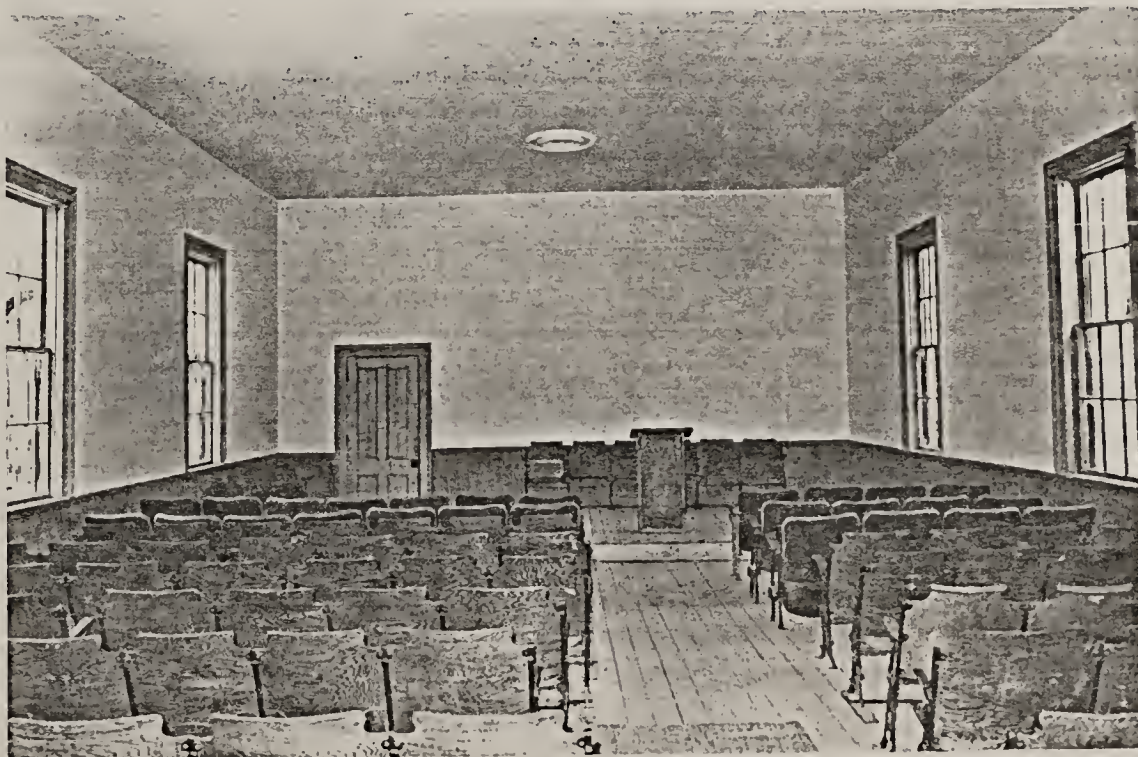
The interior has a raised pulpit platform and fixed chair seating in an asymmetrical arrangement. A beaded wood wainscot terminates with a small ledge integral with the window sill. Interior window mouldings suggest Greek Revival influence. Walls and ceiling are plaster on wood lath. The ceiling has two plaster light medallions.

Figure 3-37. Looking north at the Methodist Church interior.

The property was donated to the Department by the Methodist Church Conference in 1969. During the years 1973 and 1974, the church was stabilized and partially restored as follows: original rock foundation repaired and repointed; new concrete foundation poured inside north, east, and west foundation walls to stabilize them and to support the structure; walls and corners stabilized with bracing; siding removed and reinstalled; rafters and joists repaired; new collar ties installed; structure reroofed with cedar shingles; interior replastered on wood lath; windows and doors repaired; east chimney reconstructed.

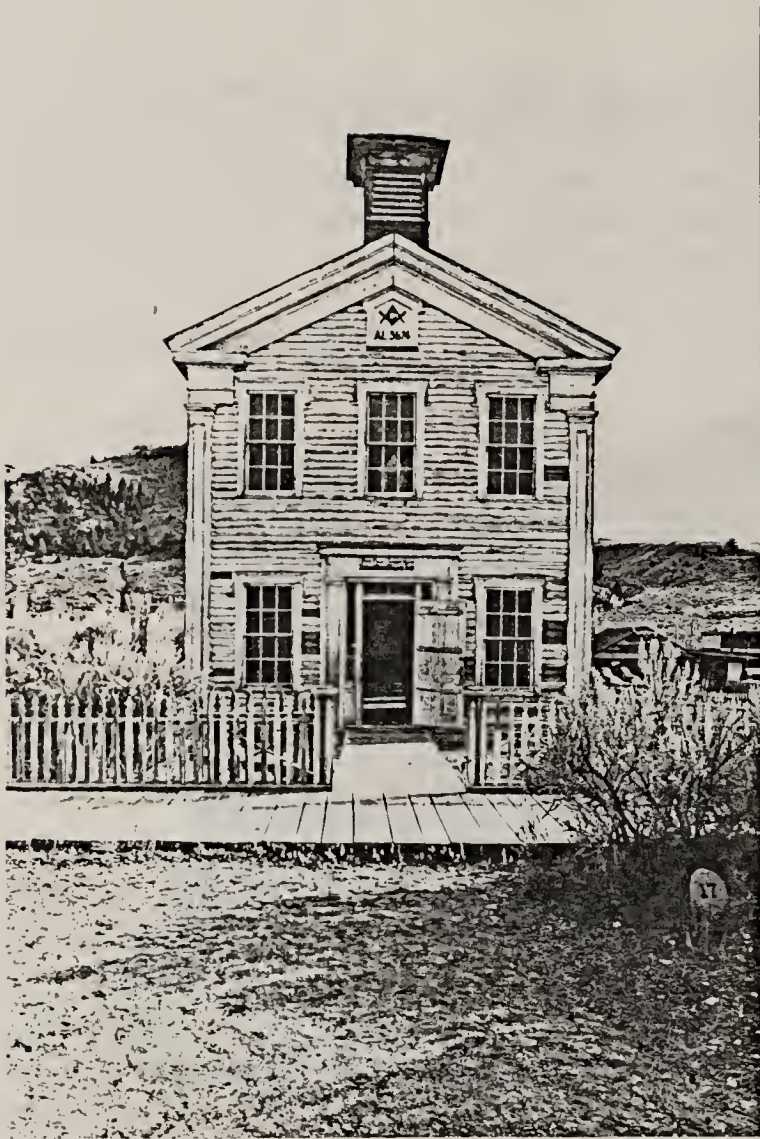
Figure 3-39. North (front) facade.

[Water table and
barge board]

[Wood walk]

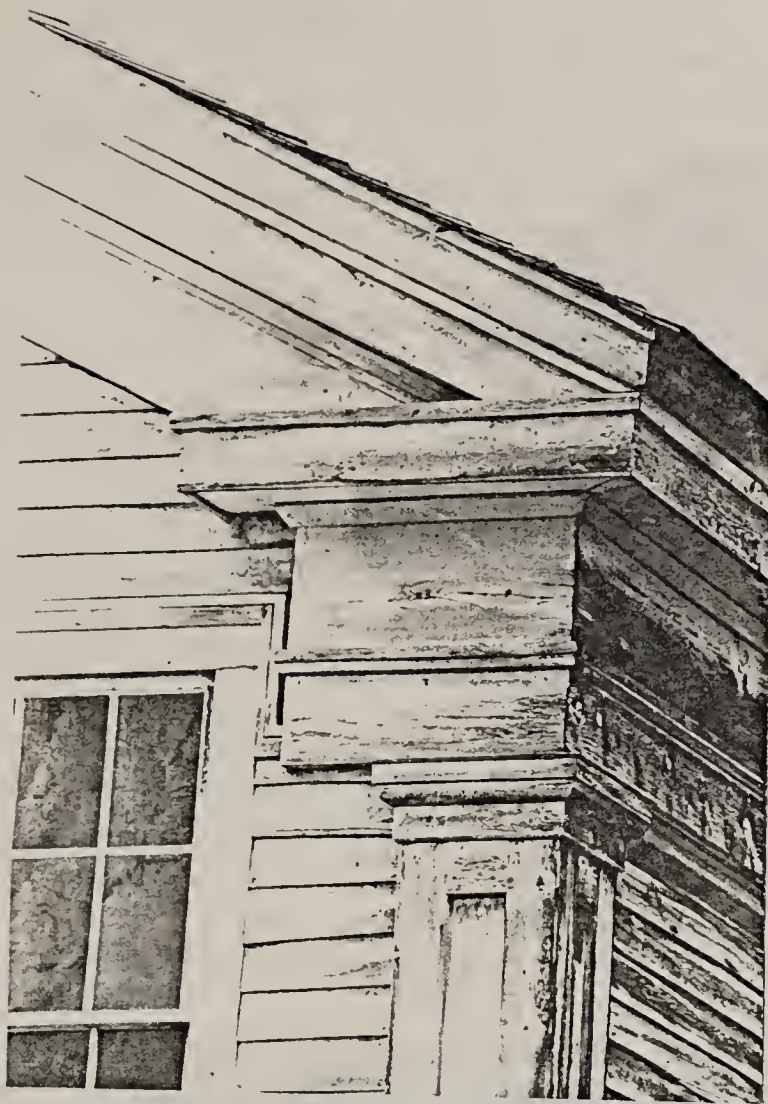
Figure 3-41. Cornice, entablature, and pilaster capital.

[Ogee corona]

[Verge board]

[Pilaster capital]

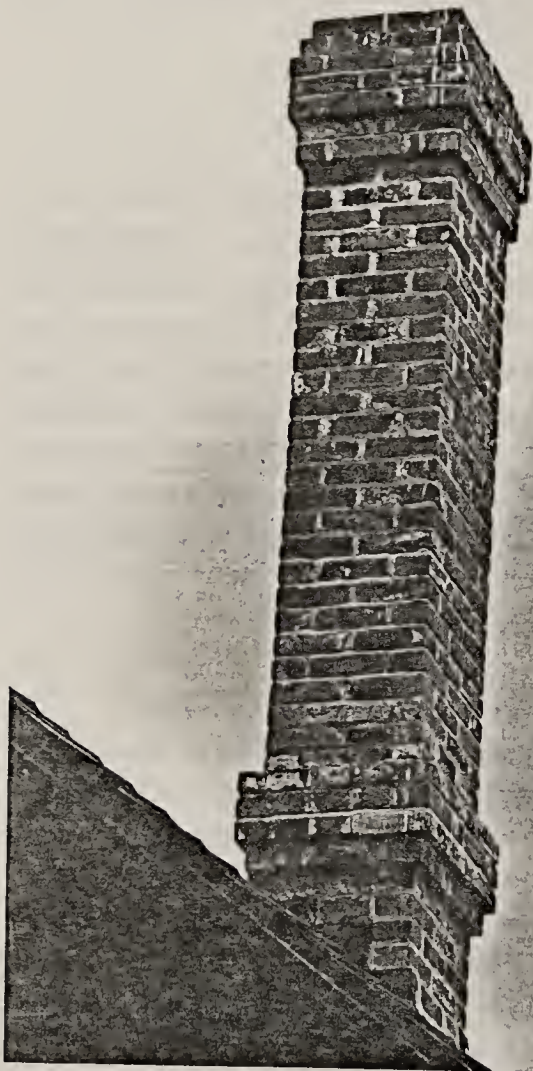
Figure 3-45. Chimney.

[Corbelling]

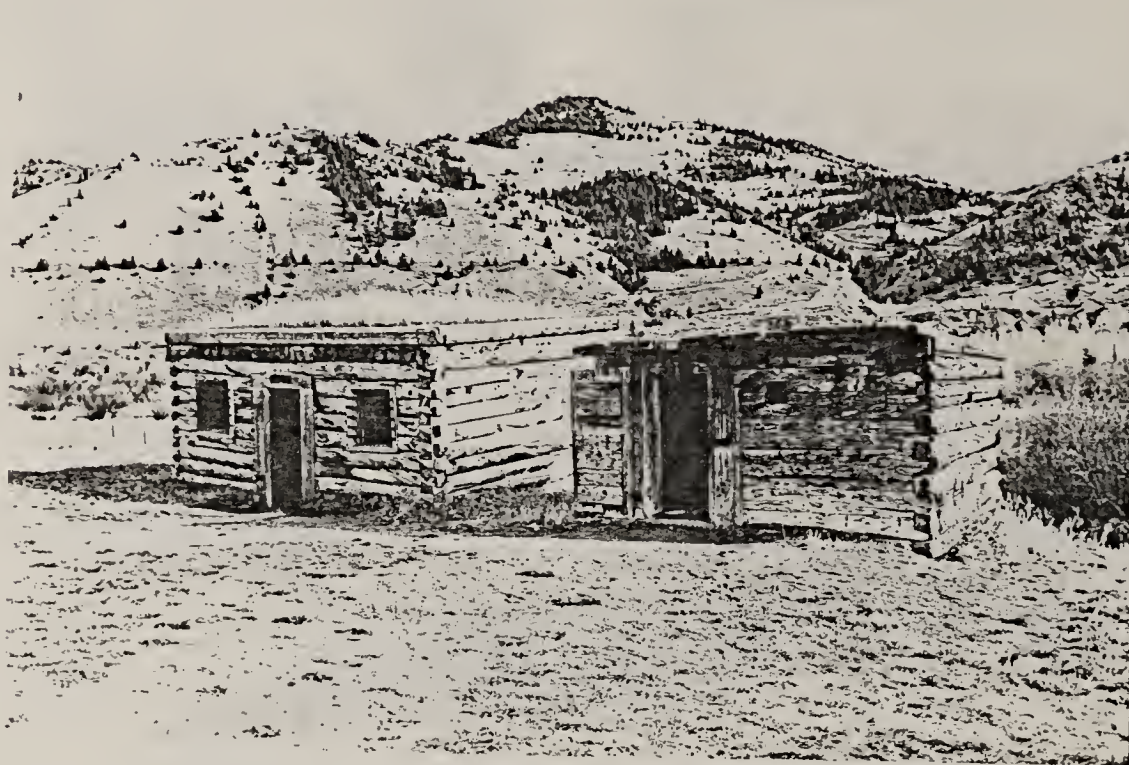
Figure 3-51. Looking southeast at jails.

The east (left) jail (HS #5) is a one-story log structure with dovetail corner notching, a hand-hewn log roof structure with sod roofing, and a board door with strap hinge. There is some mud daubing with cement mortar daubing added. Windows are framed into the walls and barred. Interior surfaces are lined with board planking nailed on four-inch centers with square nails. There is one large cell and two smaller cells with evidence that four cells and a corridor once existed. The east jail is in good condition, but with graffiti on walls. Evidence of some fire damage is apparent in both jails.

The west (right) jail (HS #6) is a hand-hewn log structure with crude dovetail notching and a temporary timber roof. There is a log and pier foundation with some concrete poured at grade in the front. Windows are small openings cut into the walls and barred. There is a board door with strap hinge. Tie-down eyelets exist on the plank floor. The west jail is in fair condition. The timber roof has been temporarily covered with roofing paper to exclude moisture.

The property (both jails) was acquired through donation to the State of Montana in 1954. The structures subsequently have been altered, restored, and stabilized as follows: 1954(?)--collapsed roof (assumed sod) on west jail replaced with timbers; 1969--concrete footings poured under portions of both structures; remnants of central frame structure between jails removed; roof of east jail rebuilt with hewn timbers, reinforced concrete slab, and sod surface.

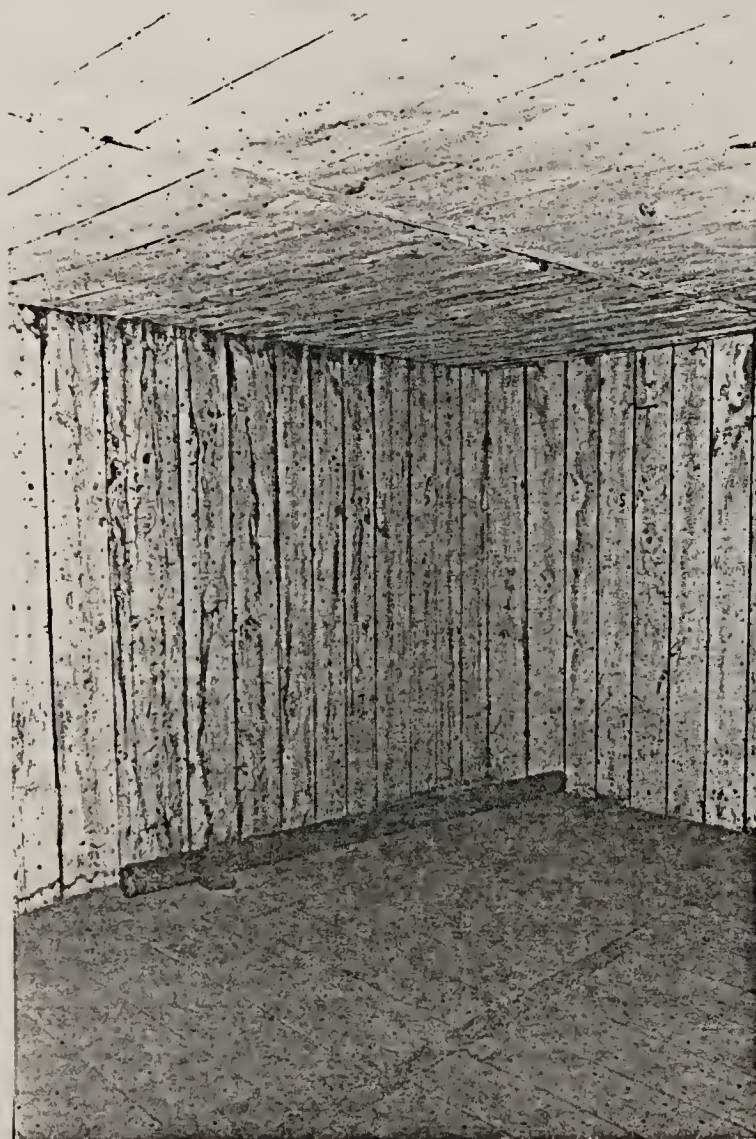
Figure 3-54. Interior of
east jail.

[Evidence of whitewash]

[Joint in floor where cell
partition removed]

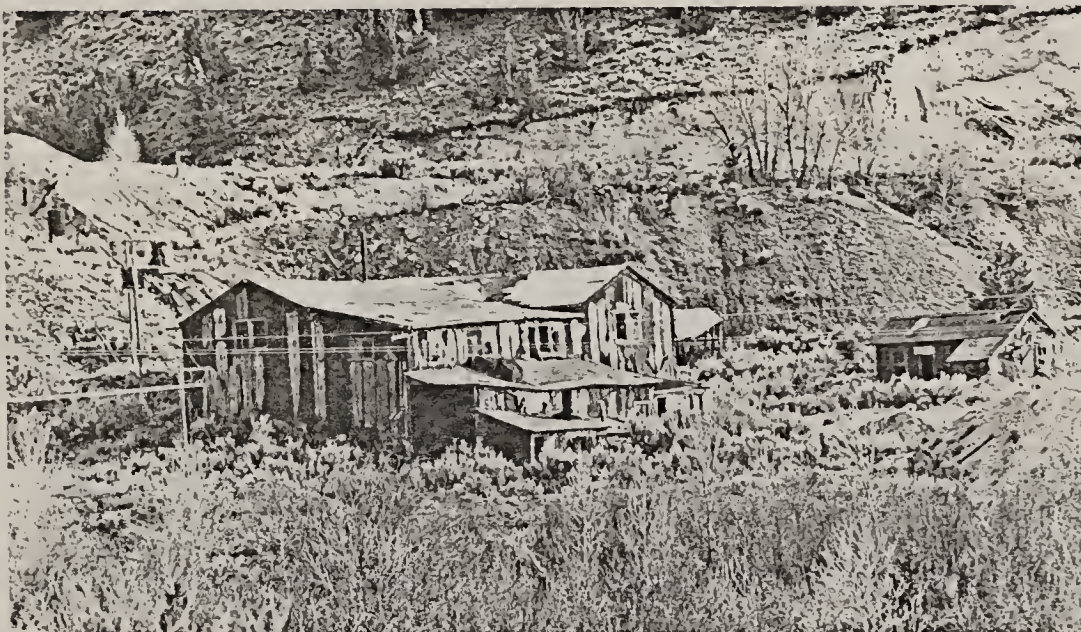
Figure 3-57. Looking southeast at mill structures.

This structure is a two-story mill building of post-and-beam construction, with vertical board and deteriorated roofing felt wall surfaces. The structure sits on some concrete piers and partial concrete foundations. There are two-over-two wood double-hung windows and six-pane wood fixed windows, some of which have been removed. The gable roof is covered with board sheathing and a layer of roofing felt, some of which has come off.

There are several shed roof structures added to the west side of the main mill, constructed of similar materials. Some of the shed roofs have caved in, causing some damage to the interiors of these rooms.

The interior of the main structure is two stories high. Inside this space are six wooden cyanide tanks used for extraction of ore. These tanks are supported off the ground by posts and beams and are connected at the top by plank walkways. The entrance to the building consists of a loading area with a boiler and separation tanks to the west of the loading dock in the shed-roofed rooms. The structure is in poor to fair condition, with some roof deterioration, exposed siding, some structural damage, and some wood rot.

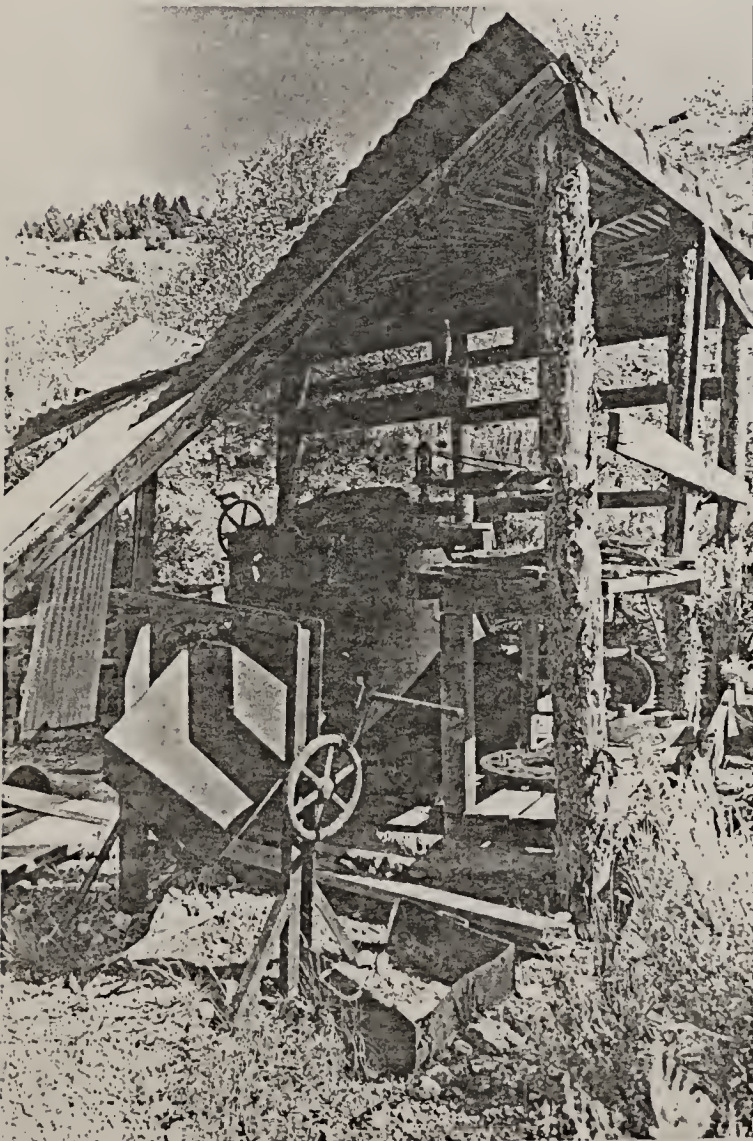
Figure 3-63. Looking northeast at a foundry structure.

The foundry building is a post-and-pole structure with a corrugated metal roof that has partially caved in. The foundry equipment is still there. The structure is in poor condition.

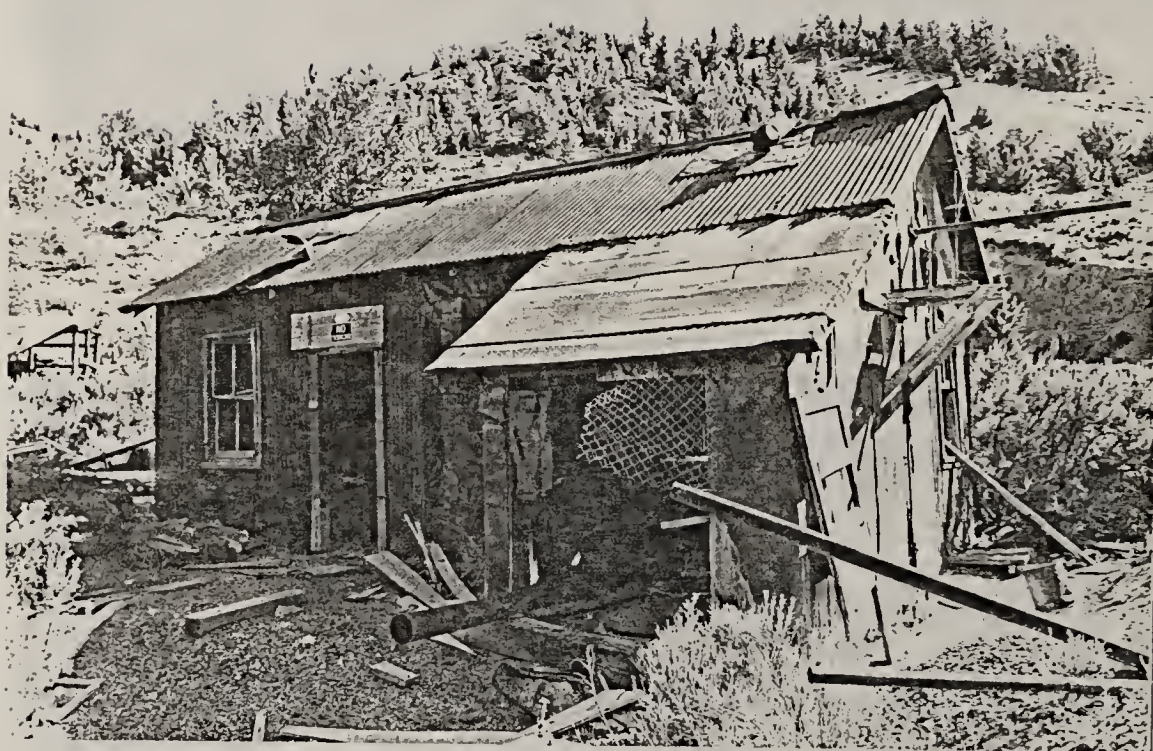
Figure 3-64. Looking southeast at the office and lab building.

The lab and office is a wood frame structure with corrugated metal over the wood siding and a pitched gable roof. There are two-over-two double-hung windows and a panel door that have been broken out. There is no visible foundation.

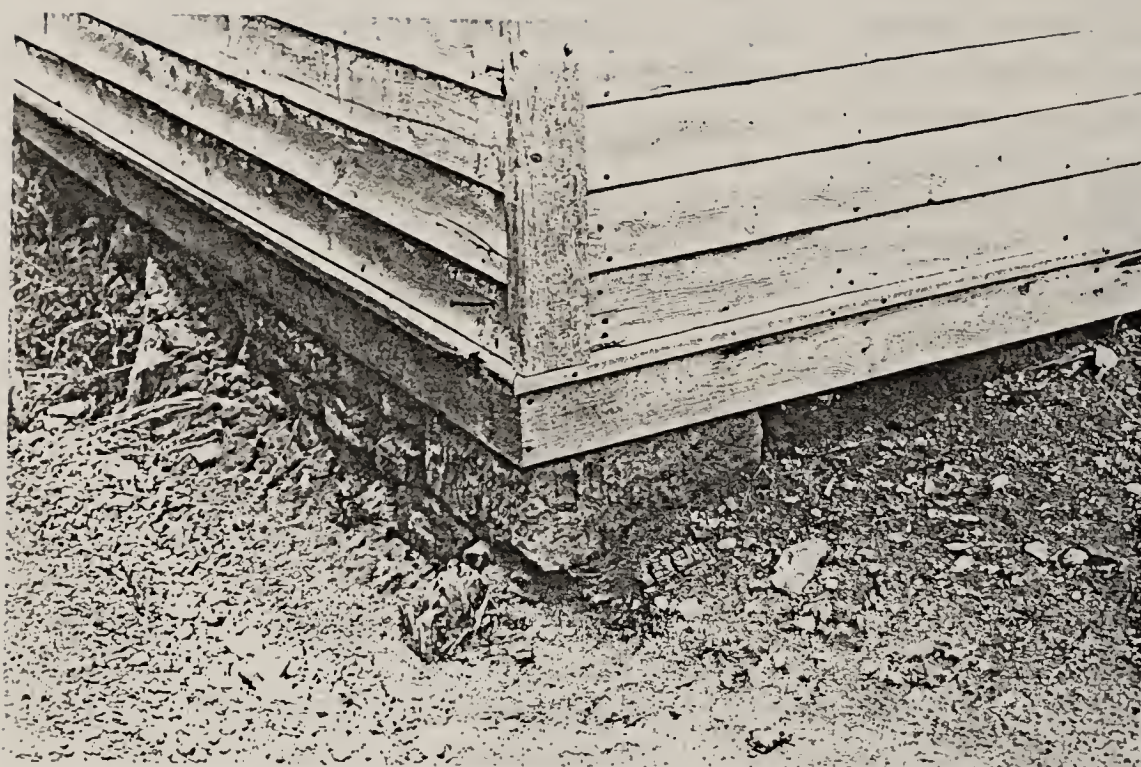
Figure 3-69. Corner at base.

[Clapboard siding
with corner board]

[Water table and
barge board]

[Stone foundation]

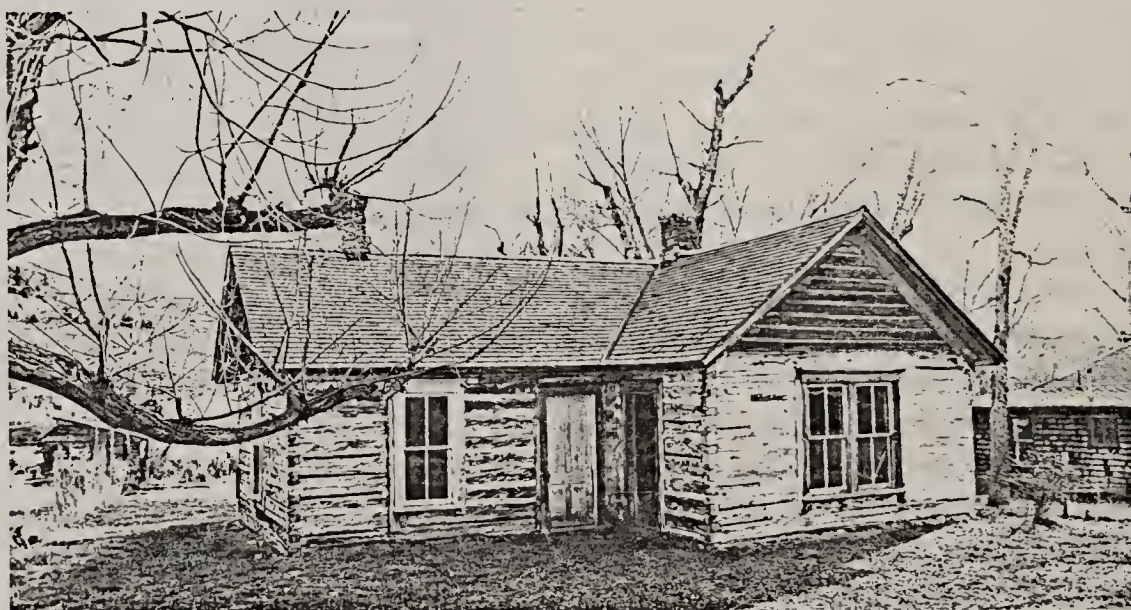
Figure 3-72. Looking southwest at the Ryburn residence.

The residence is in fair condition, with deteriorating logs, stone work, and trim. Interiors have water damage, and there are new materials on some walls and ceilings. An outbuilding, used as a garage, exists to the south of the residence. It is wood frame with pitched gable roof in very poor condition, with deteriorating wood and doors missing.

The property was acquired through donation to the State of Montana in 1954, and has been stabilized and partially restored as follows: 1972-73--stone foundation repaired, concrete footing poured as necessary; rotten wall logs replaced; new cedar shingles installed on house and garage.

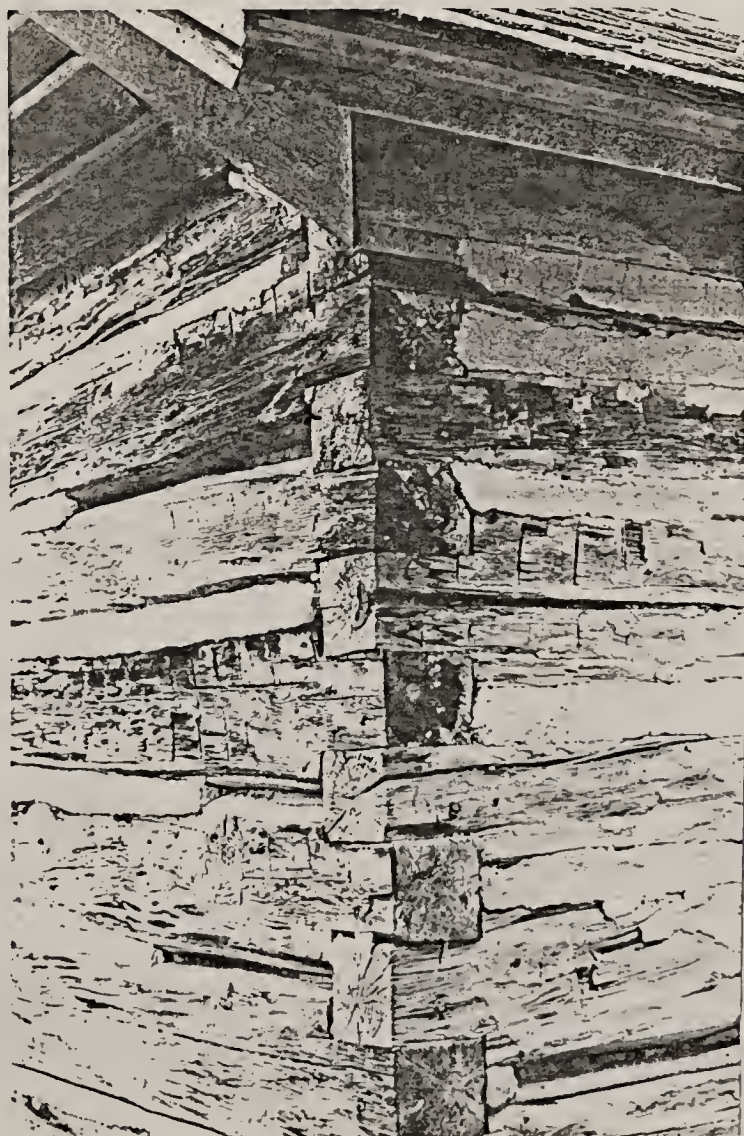
Figure 3-73. Corner detail of Ryburn residence.

[Missing mortar]

[Deteriorating logs]

[Evidence of whitewash]

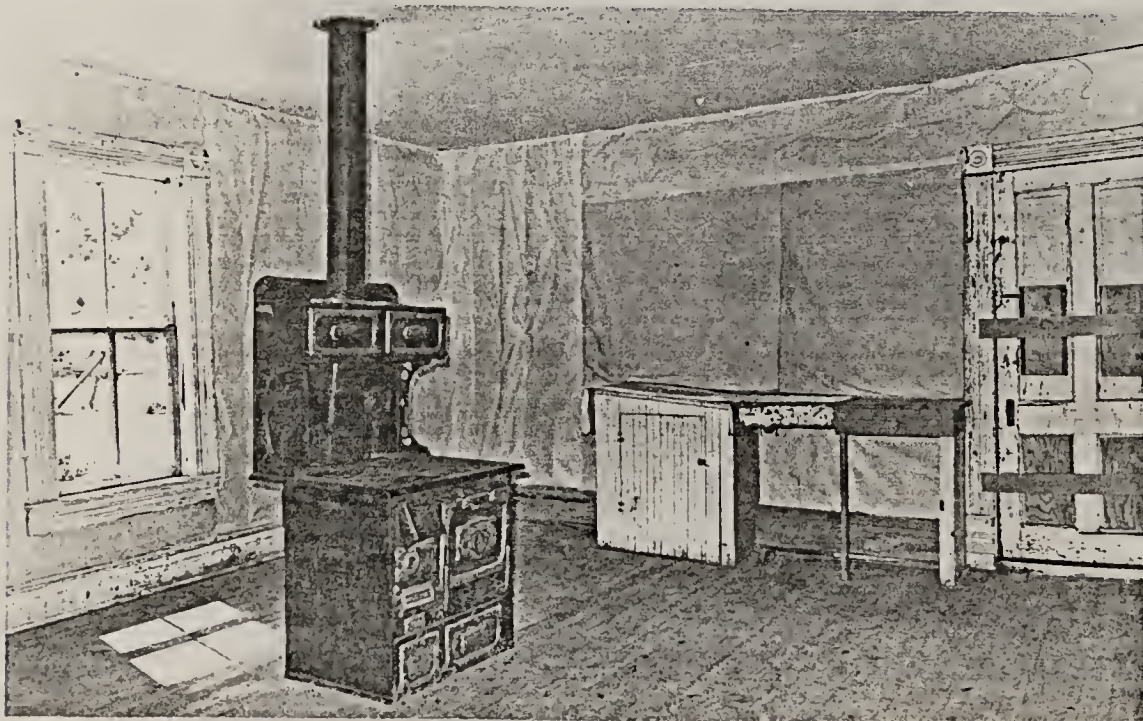
Figure 3-75. Kitchen of Ryburn residence.

[New materials]

[Wood panel door]

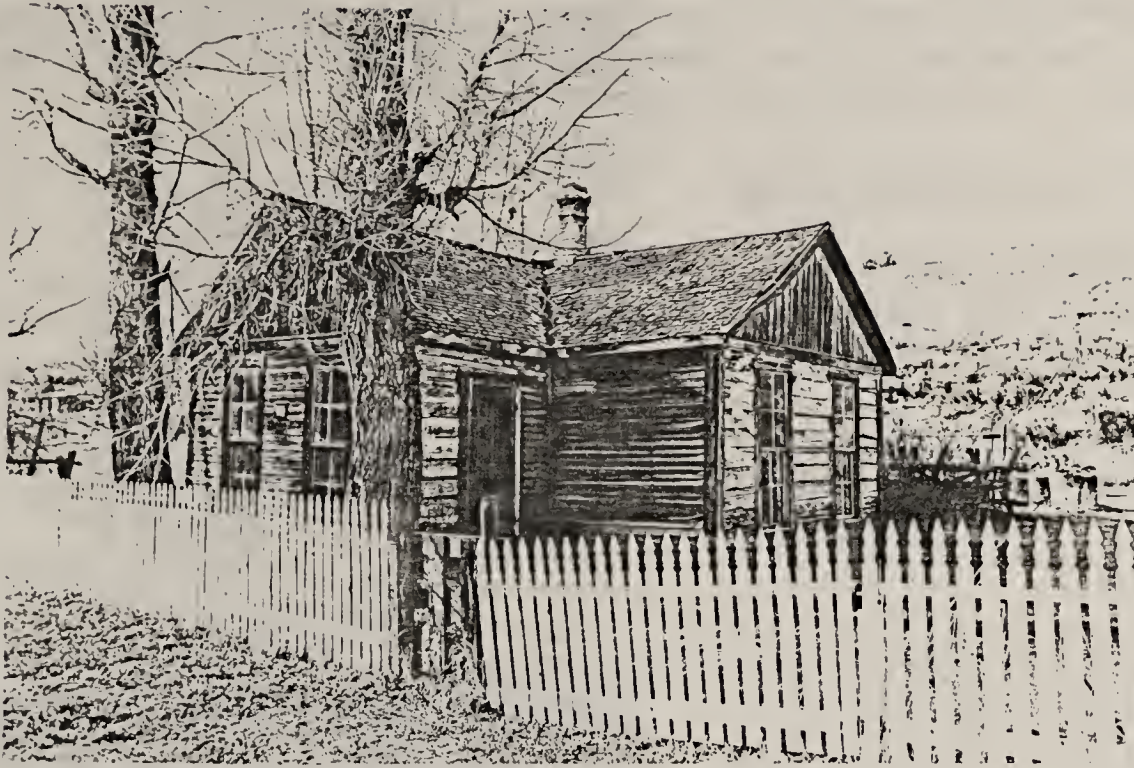
Figure 3-76. Looking northwest at residence.

The house is in fair condition. There is no visible foundation, sill logs are rotted, and shingles and log daubing are deteriorating. The interior of the house is in poor condition, with severe floor heaving and water damage.

The property was acquired through donation to the State of Montana in 1954. The chimney, doors and windows were repaired in 1972.

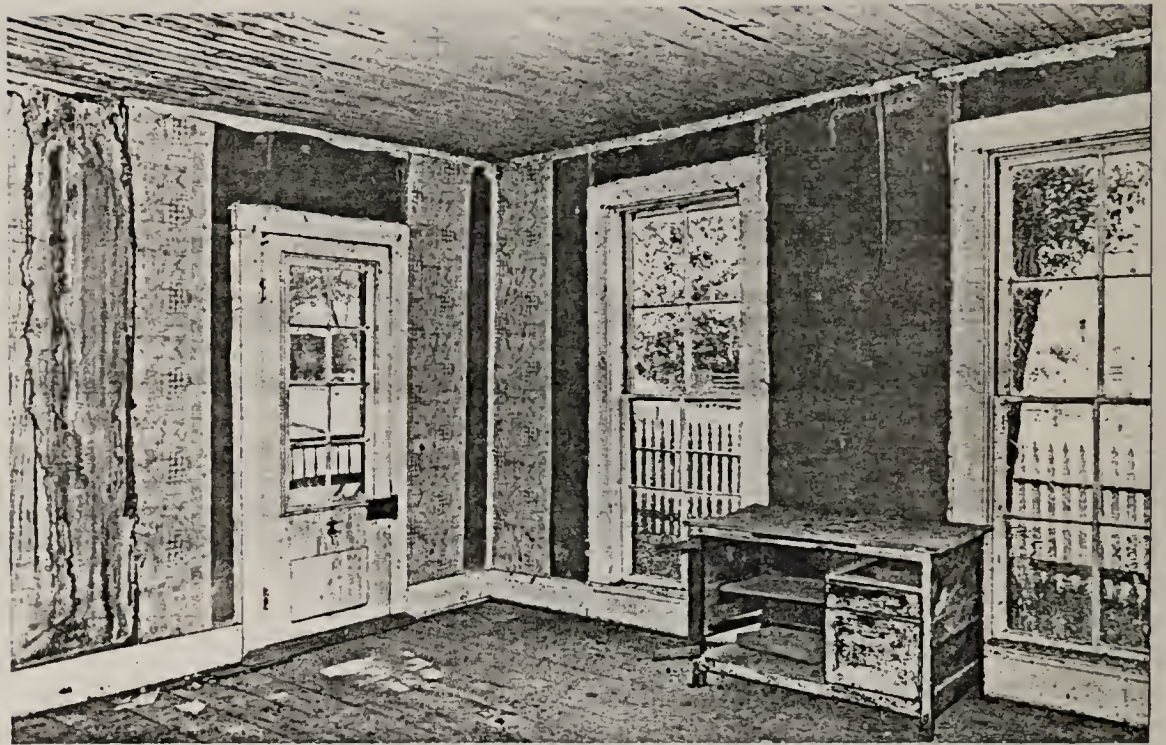
Figure 3-80. Looking at the front room interior.

[Water damage from
roof leaks]

[Note doors and
windows]
